Emergency Treatment of Acid Mine Drainage at the Leviathan Mine with the Rotating Cylinder Treatment System (RCTS™)

T. K. Tsukamoto *Ionic Water Technologies, USA*

Abstract

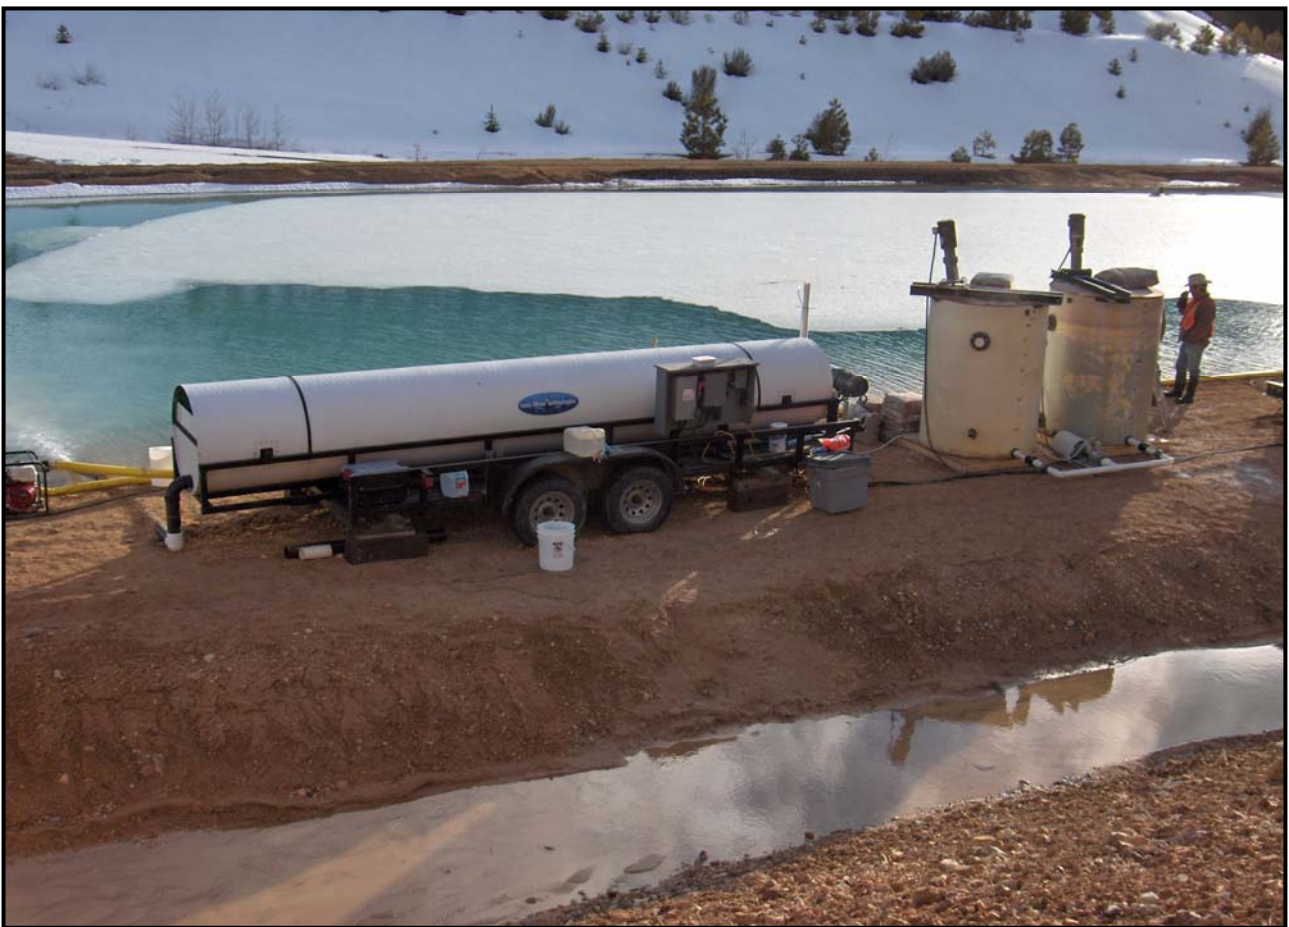
Figure 1 2006 RCTS-HS Treatment System

Acid mine drainage typically contains sulfuric acid along with elevated concentrations of dissolved ferrous iron and other metals. The oxidation of ferrous iron to ferric iron is a commonly used process in most lime treatment systems because ferric iron is precipitated from solution at a lower pH than ferrous iron. Treating AMD at a lower pH allows for treatment of iron and aluminum in a single stage. This oxidation is typically accomplished by pumping air with compressors and mixing the air, lime and AMD with agitation mixers in large tanks. Although this method of treatment is effective, it requires significant power and a large amount of space to house the reaction tanks. The patented Rotating Cylinder Treatment System (*RCTSTM*) utilizes shallow trough-like cells or cylinders (that contain the AMD being treated) and rotating cylinders within these cells to transfer oxygen and agitate the AMD. This system has been tested on multiple sites in Nevada, Idaho and California. When compared with conventional systems it requires less power (<1800 watts) and less space and is more efficient at mixing lime (near 100% efficiency). Figure 1 displays the RCTS-HS system utilized for the Pond 3 Emergency Treatment in 2006.

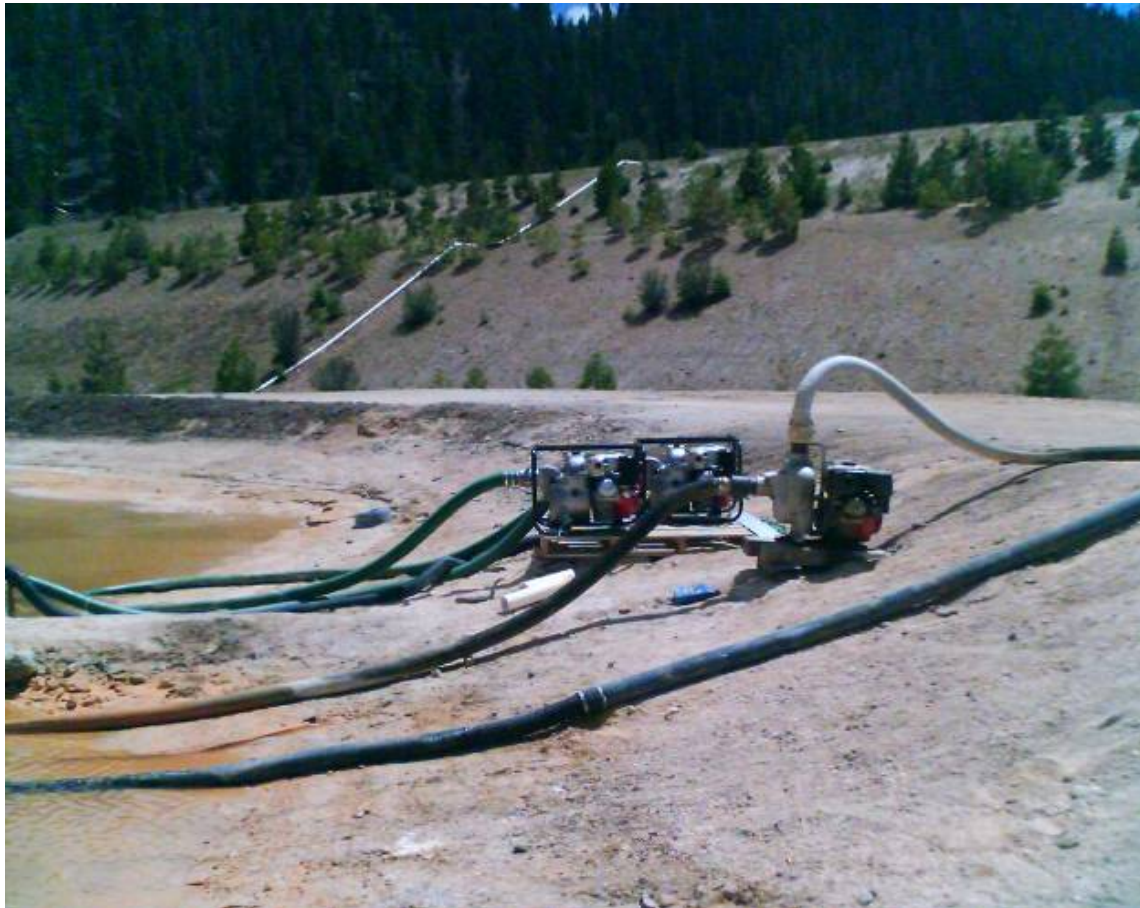
Figure 2 Water discharge from Pond 3 to the Leviathan Creek.

began with the use of pumps and siphon hoses. By actively discharging at a higher rate than the inflow, Pond 3 was drawn down, creating freeboard. This allowed the AMD to be treated and contained in Pond 3 until the water was suitable for a controlled discharge. Figures 2 and 3 display the discharge pumping setup. On April 25 a siphon line was installed to gravity feed AMD from Pond 1 directly into the *RCTS™* Treatment System. By doing this, the level in the upper ponds was drawn down which reduced the amount of AMD that overflowed from the upper ponds to Pond 3. By June 4, overflow had decreased to less than 3 gallons per minute.

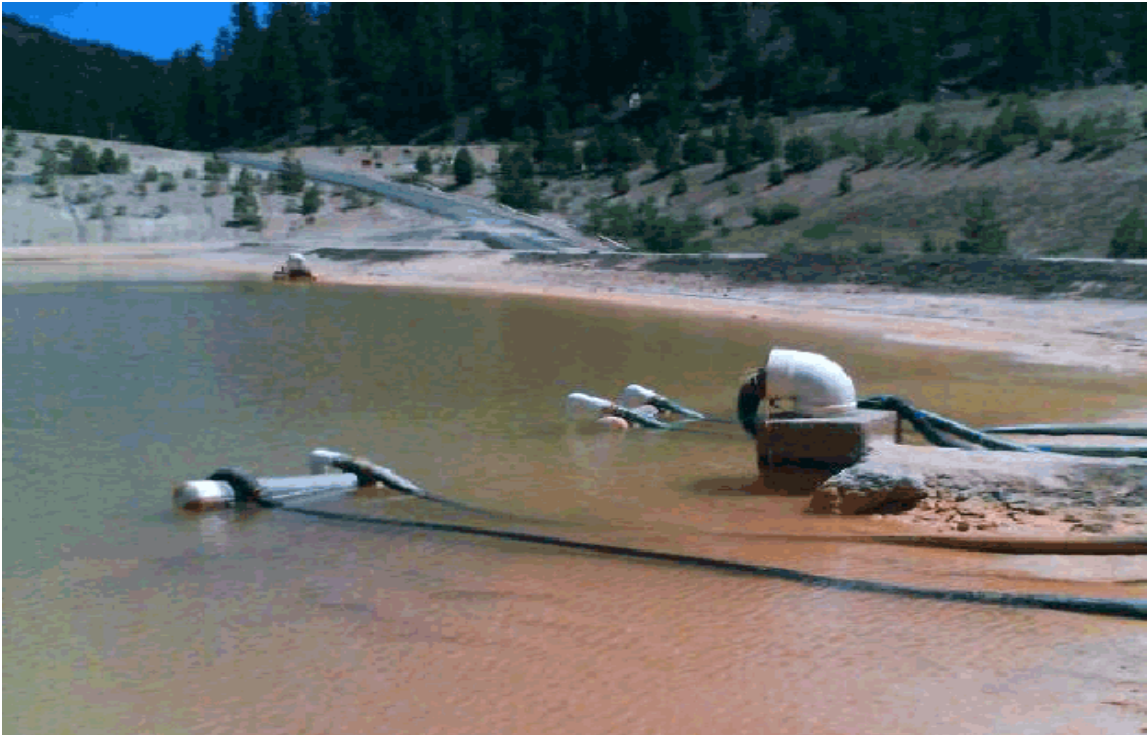
Figure 3 Suction lines located near surface to avoid discharge of sediments.

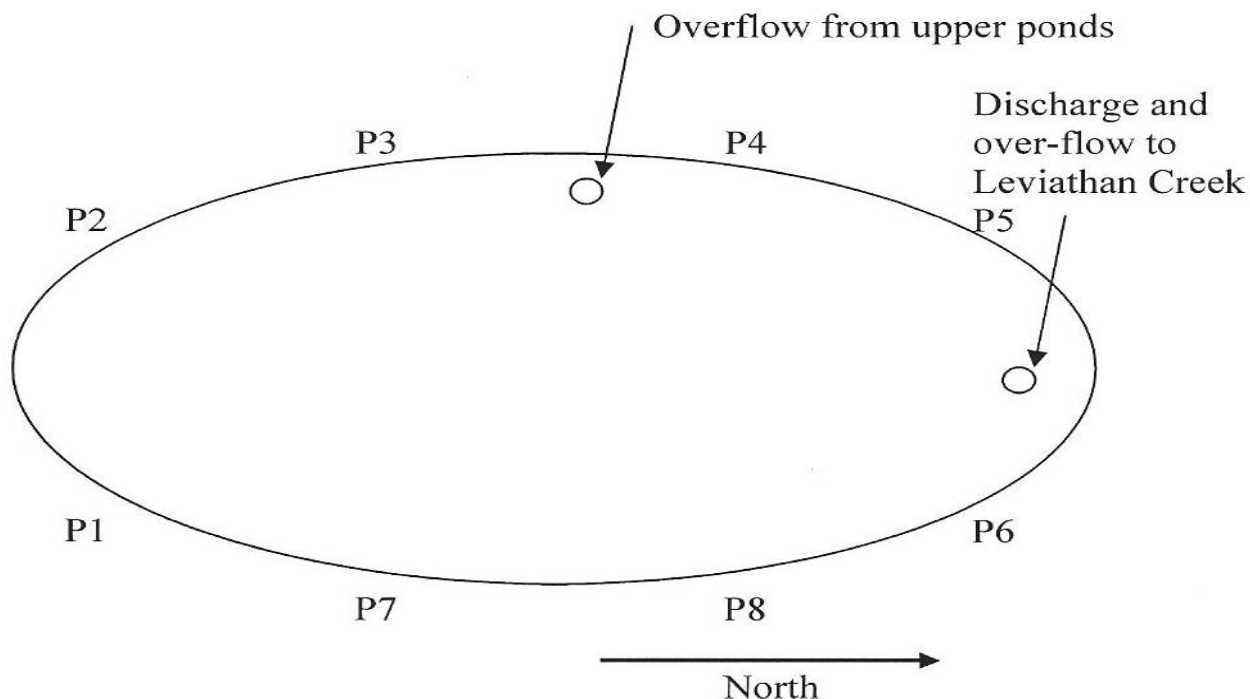
Figure 4 Pond 3 monitoring stations

Pond 3 monitoring was conducted multiple times per day on most treatment days. Pond 3 monitoring stations are displayed in Figure 4.

TKT field monitoring included the determination of flow, pH, oxidation-reduction potential (ORP), conductivity, dissolved oxygen (DO), and temperature. Discharge flow rates were estimated from pump and pipe manufacturer's specs. All other field measurements were measured with a Yellow Springs Instrument (YSI) 556-field meter, calibrated before each visit. Certified laboratory samples were taken by the Water Board staff at least once on discharge days following protocols defined in the Water Board's "Sampling and Analysis Plan for Surface Water Monitoring" (January 2004) and were sent to Weck Laboratories in Industry, CA for analysis. Grab samples were collected from near the discharge point in Pond 3 and the pH was monitored continuously on discharge days. Sampling stations were as follows: Pond 1, Pond 2 S, and Pond 3.

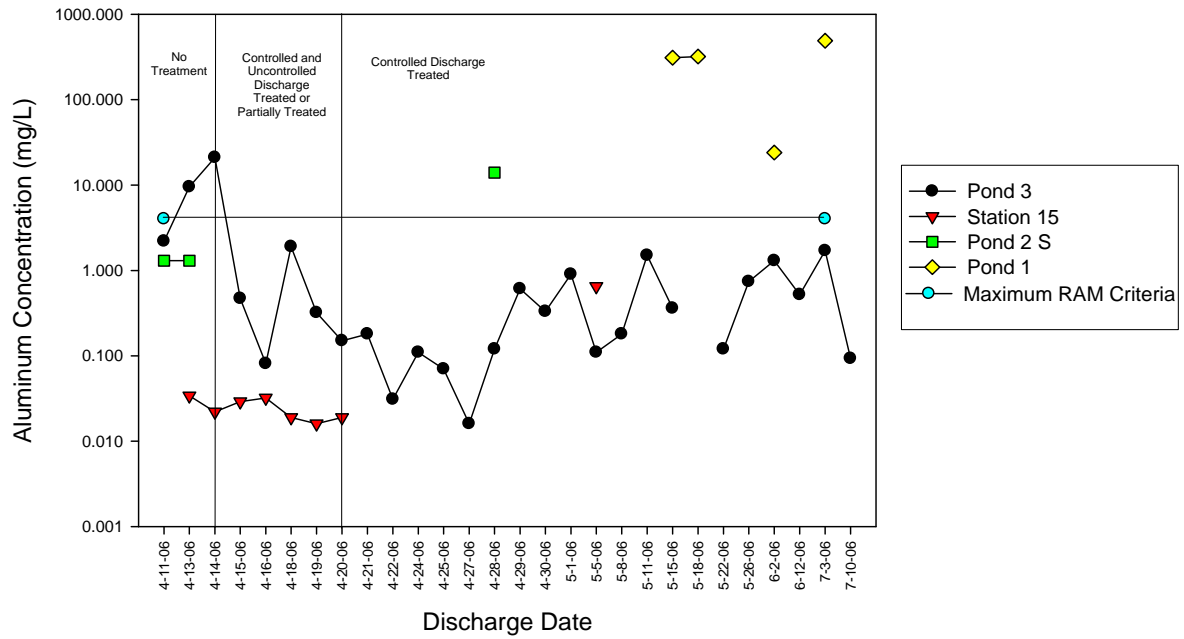
Figure 5 Leviathan pond 3 Aluminum concentrations

Once treatment began during the 2006 Spring Treatment, the maximum daily RAM discharge objectives were not exceeded, with the exception of iron which slightly exceeded the objective once. Aluminum, iron and copper exceeded the RAM discharge objectives prior to treatment. Copper and aluminum exceeded discharge objective on April 14 just following the initiation of treatment. Selenium (which is not removed effectively by lime precipitation without the presence of high concentrations of other metals which co-precipitate) exceeded the four day average RAM objective between April 14 and April 22. Figures 5, 6 and 7 graphically display the data over time for Aluminum, Iron and Copper. Water was treated 24 hours per day, 7 days per week from April 19 to July 7. The controlled discharges occurred when the capacity of Pond 3 was near full and the pH of Pond 3 near the discharge point was between 7 and 9. A target discharge pH of 8.0 to 8.5 s.u. was set, however the Pond 3 pH sometimes varied and in a few circumstances the discharge was stopped do to the pH approaching 7 or 9 s.u. Samples were taken during discharge whenever practical however on April 27 and April 28 the samples were taken after the discharge had been stopped and on May 5 the samples were taken prior to discharge.
